**Docket No. 217 – Development and Management Plan Inspection**

Northeast Utilities Service Company Certificate of Environmental Compatibility and Public Need for the construction of a 345-kV electric transmission line and reconstruction of an existing 115-kV electric transmission line between Connecticut Light and Power Company's Plumtree Substation in Bethel, through the towns of Redding, Weston, and Wilton, and to the Norwalk Substation in Norwalk, Connecticut.

**Date:** October 18, 2006

**Location:** Transition Stations: Hoyts Hill, Archers Lane, Norwalk Junction

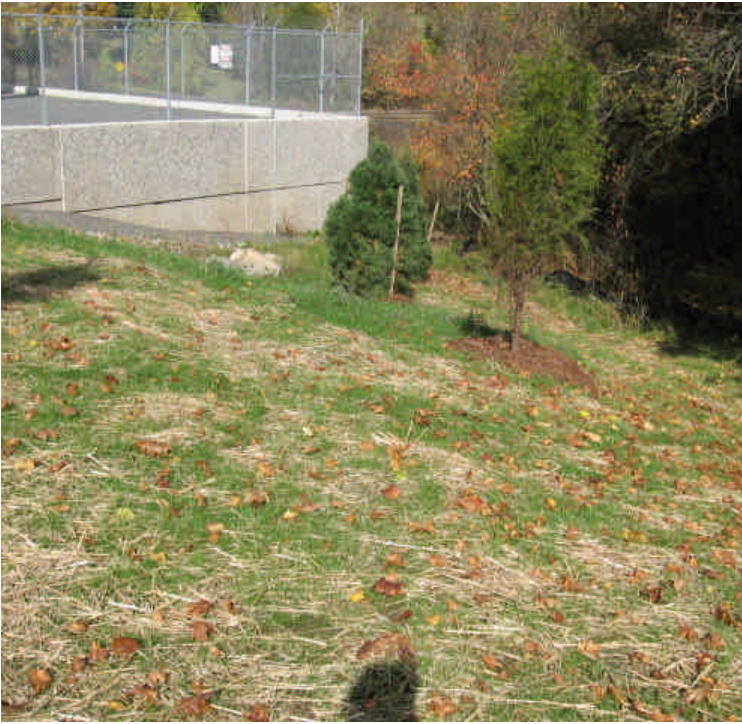
Hoyts Hill Transition Station: Photo on the left shows the southern slope which is well restored with good grass cover. Photo on the right shows silt fence remaining along the wetland edge. This could be removed at any time. 10/18/06.

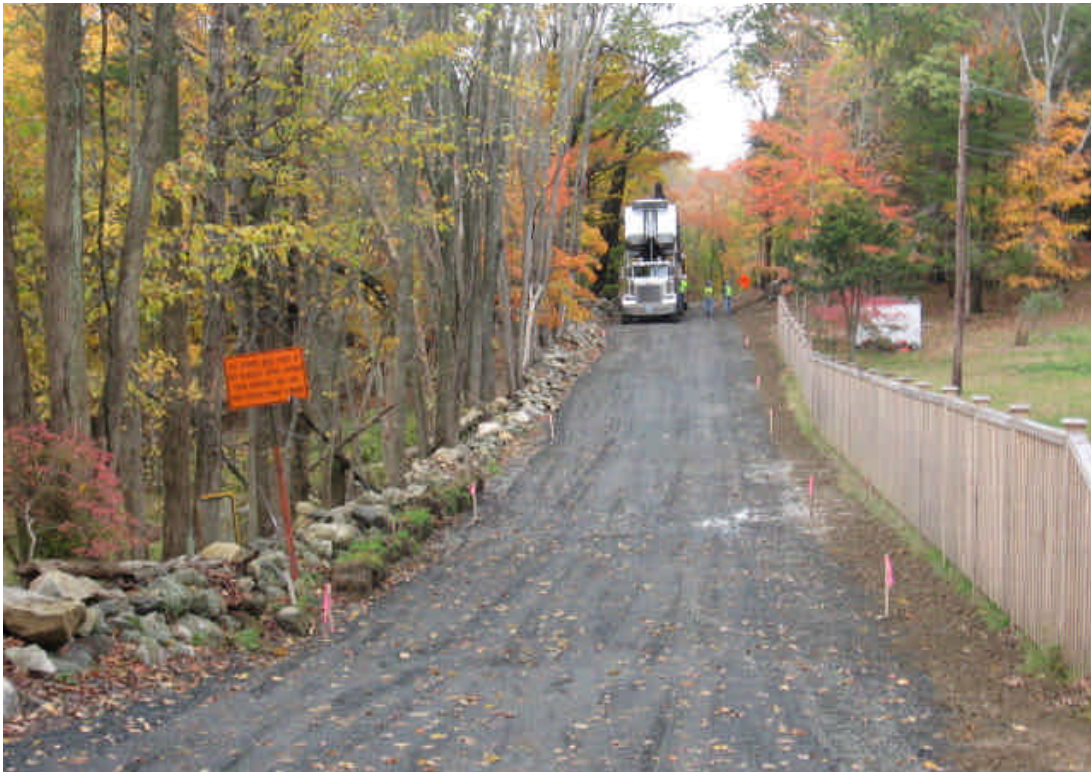
Archers Lane Transition Station: Photo on the left shows crews placing stone dust base on the access road in preparation for paving. 10/18/06.

- Crews were installing stone dust base on the access drive off Diamond Hill Road, in preparation	-Continue to monitor until final stabilization is complete in this area. 10/18/06.	-N/A

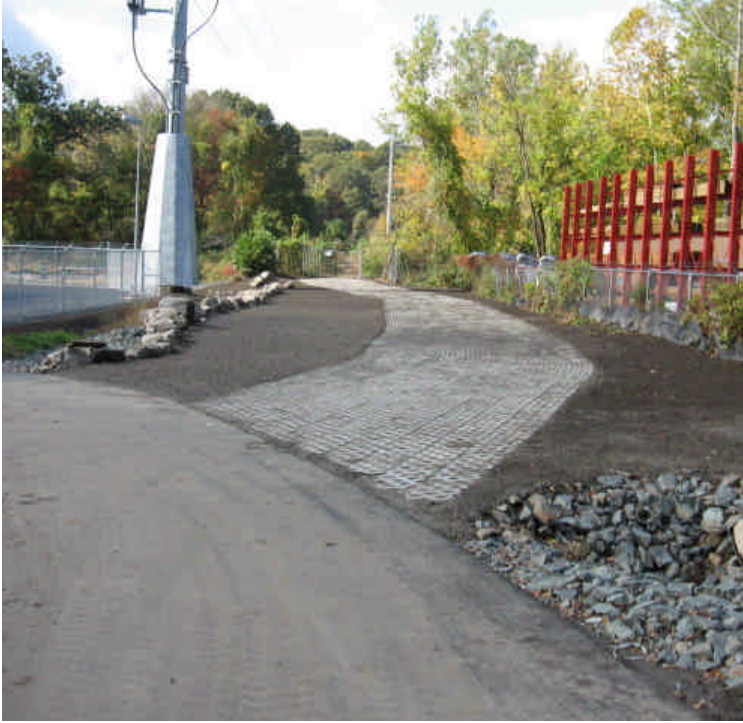
**Norwalk Junction: Photo on the left shows the pervious pavers installed off the driveway. Adjacent areas were loamed. Photo on the right shows a washout that has occurred in the recently installed loam on the slope of the swale. 10/18/06.**

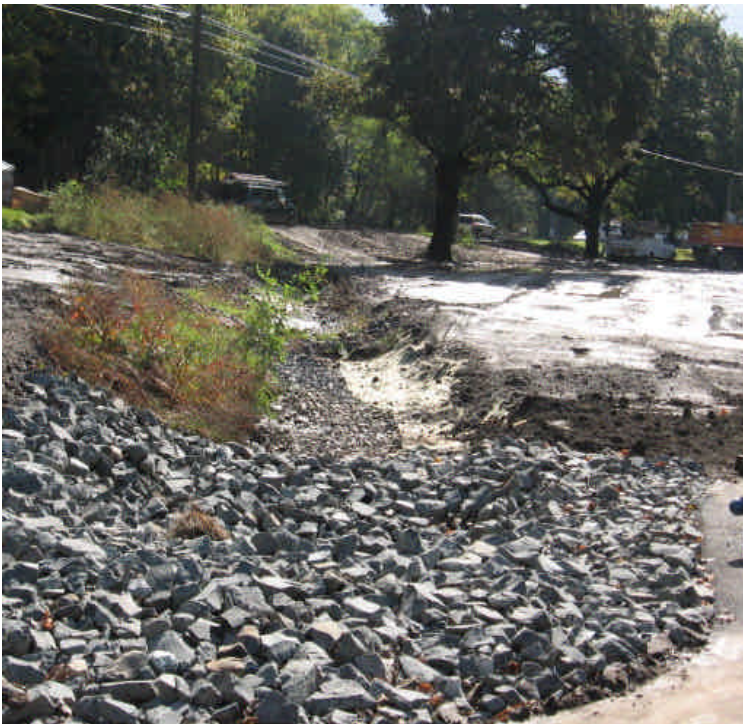
**Photo on the right shows where the disturbed area near Rt 7 has been graded and loamed. Mulch should be spread on the entire area in an effort to stabilize it temporarily before the winter. Photo on the right shows some turbid water in the wetland area, potentially due to run-off from the swale. However, sediment had not accumulated. 10/18/06.**
